Contract #: 04-0120F4Cty: SF/ALA Rte: 80 PM: 13.2/13.9File #: 69.28**WELDING INSPECTION REPORT****Resident Engineer:**Siegenthaler, Peter**Address:** 333 Burma Road**City:** Oakland, CA 94607**Report No:** WIR-023116**Date Inspected:** 26-Apr-2011**Project Name:** SAS Superstructure**OSM Arrival Time:** 700**Prime Contractor:** American Bridge/Fluor Enterprises, a JV**OSM Departure Time:** 1900**Contractor:** Zhenhua Port Machinery Company, Ltd (ZPMC), Changxing Island **Location:** Shanghai, China**CWI Name:** Liu Hua Jie**CWI Present:** Yes No**Inspected CWI report:** Yes No N/A**Rod Oven in Use:** Yes No N/A**Electrode to specification:** Yes No N/A**Weld Procedures Followed:** Yes No N/A**Qualified Welders:** Yes No N/A**Verified Joint Fit-up:** Yes No N/A**Approved Drawings:** Yes No N/A**Approved WPS:** Yes No N/A**Delayed / Cancelled:** Yes No N/A**Bridge No:** 34-0006**Component:** Orthotropic Box Girder(OBG)**Summary of Items Observed:**

WELDING INSPECTION REPORT

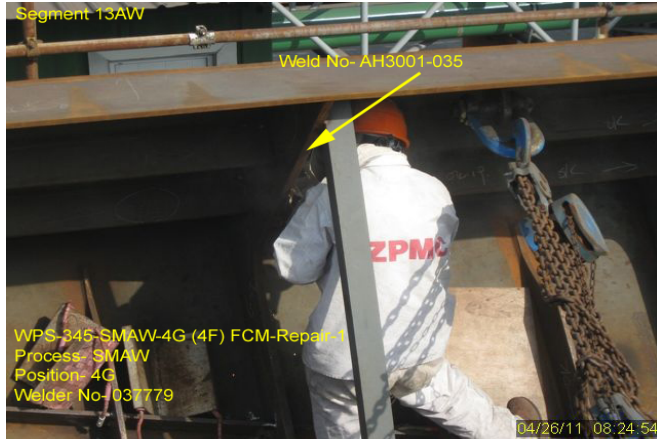
This QA Inspector observed ZPMC qualified welding personnel identified as 037779 perform Shielded Metal Arc Welding (SMAW), weld joint identified as AH3001-035; located On Orthotropic Box Girder (OBG) X4193C to X4208B CJP Weld; ZPMC Quality Control (QC) is identified as Mr. Shen Jian Bo. This QA Inspector observed the base material appears to have been preheated by an electrical heating element prior to welding. The Welding Repair Report (WRR) was B-WR20812. ZPMC Quality Control (QC) Mr. Shen Jian Bo was onsite monitoring the welding variables. The welding variables recorded by QC appeared to comply with applicable WPS-345-SMAW 4G (4F)FCM-Repair-1. See attached photo for further details.

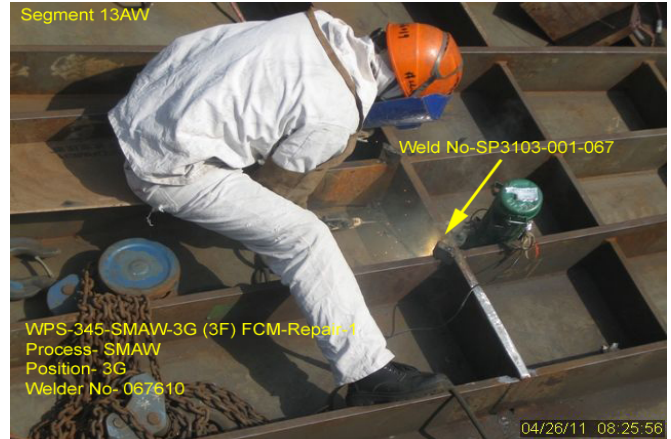
This QA Inspector observed ZPMC qualified welding personnel identified as 067610 perform Shielded Metal Arc Welding (SMAW), weld joint identified as SP3103-001-067; located On Orthotropic Box Girder (OBG) X4192B to RS3448H CJP Weld; ZPMC Quality Control (QC) is identified as Mr. Shen Jian Bo. This QA Inspector observed the base material appears to have been preheated by an electrical heating element prior to welding. The Welding Repair Report (WRR) was B-WR20811. ZPMC Quality Control (QC) Mr. Shen Jian Bo was onsite monitoring the welding variables. The welding variables recorded by QC appeared to comply with applicable WPS-345-SMAW-3G(3F)FCM-Repair-1. See attached photo for further details.
